**Flood Control Project Maintenance
Levee Inspections**

Maintenance Issue Types Only, Levee Inspection Report By Mile - Spring 2020

Sutter Maintenance Yard Hamilton Bend

Waterway	Bank	Unit Miles	Inspection Start/End	Inspector
Unit No. 01 Feather River Hamilton Bend	Right	3.39	03/18/2020 03/18/2020	Sterling York

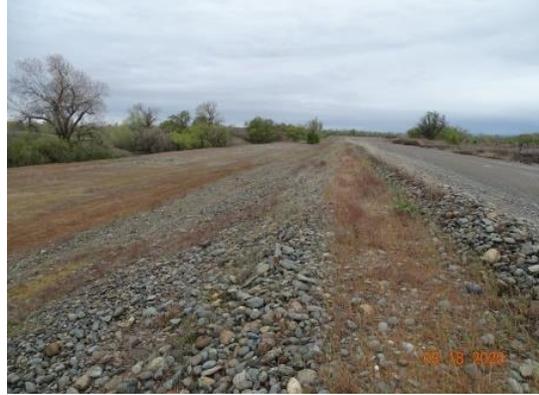
Photo 1 of 1 : SP_2020_ST0005_289_3_20200327_00012.jpg

LM Start	0.01	Rating **	A	Issue No.	3
LM End	1.22	Issue Type +	Ma	Location *	LS
Category	Earthen Levee		GPS Latitude/Longitude		
			Start	End	
Item	Vegetation		39.439776 °	39.456841 °	
			-121.641456 °	-121.639320 °	
DWR ID	DWR_ST0005_01_s_2020_3				
Comment Code					
V1 : Control annual grass and weeds on the levee slopes and easements.					
Inspector Comment					
The annual vegetation is well maintained in this section, Spring 2020.

View looking upstream landside at the well maintained annual vegetation, Spring 2020.

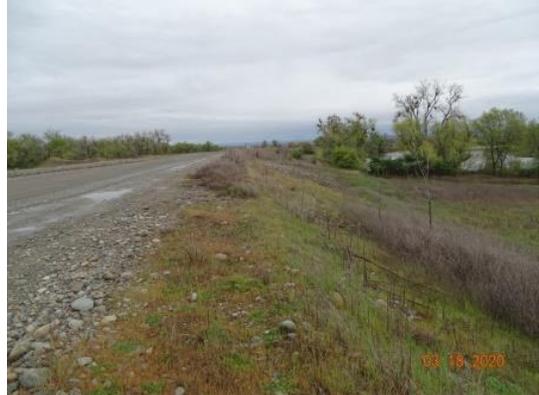
Photo 1 of 1 : SP_2020_ST0005_289_5_20200327_00013.jpg

LM Start	0.01	Rating **	A	Issue No.	5
LM End	1.22	Issue Type +	Ma	Location *	WS
Category	Earthen Levee		GPS Latitude/Longitude		
			Start	End	
Item	Vegetation		39.439776 °	39.456842 °	
			-121.641457 °	-121.639320 °	
DWR ID	DWR_ST0005_01_s_2020_5				
Comment Code					
V1 : Control annual grass and weeds on the levee slopes and easements.					
Inspector Comment					
The annual vegetation is well maintained in this section, Spring 2020.

View looking upstream waterside at the well maintained annual vegetation, Spring 2020.

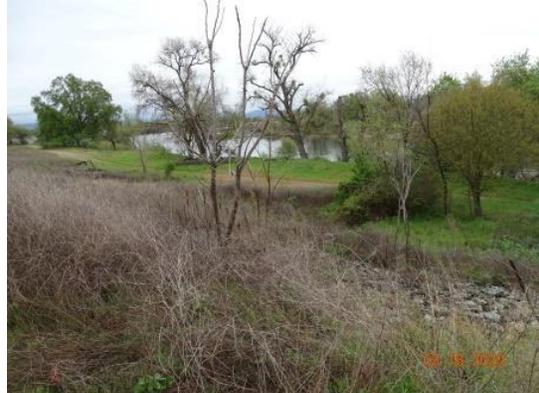
Photo 1 of 1 : SP_2020_ST0005_289_12_20200327_00014.jpg

LM Start	0.71	Rating **	M	Issue No.	12
LM End	0.91	Issue Type +	Ma	Location *	WS
Category	Earthen Levee			GPS Latitude/Longitude	
				Start	End
Item	Trim / Thin Trees			39.449757 °	39.452614 °
				-121.640886 °	-121.640284 °
DWR ID	DWR_ST0005_01_s_2020_12				
Comment Code					
T3 : Trim and thin trees to allow visibility of the ground and room to flood fight.					
Inspector Comment					
Trees that are less than 4" in diameter need to be removed, Spring 2020.

View looking upstream waterside at trees that are less than 4" in diameter that need to be removed, Spring 2020.

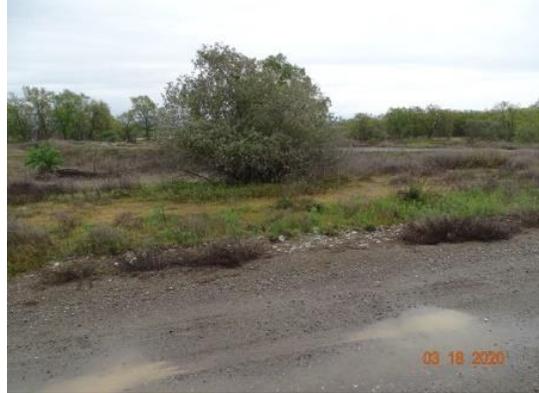
Photo 1 of 1 : SP_2020_ST0005_289_10_20200327_00015.jpg

LM Start	0.97	Rating **	M	Issue No.	10
LM End	0.97	Issue Type +	Ma	Location *	WS
Category	Earthen Levee		GPS Latitude/Longitude		
			Start	End	
Item	Trim / Thin Trees		39.453512 °	39.453512 °	
			-121.640272 °	-121.640272 °	
DWR ID	DWR_ST0005_01_s_2020_10				
Comment Code					
T2 : Thin trees to allow visibility of the ground and room to flood fight.					
Inspector Comment					
Trim tree for visibility, Spring 2020.

View looking waterside at a tree hat needs to be trimmed for visibility, Spring 2020.

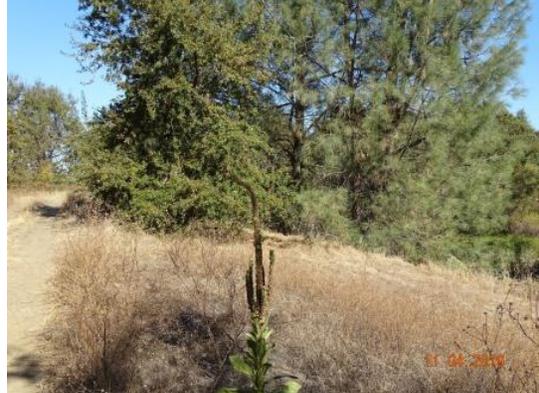
Photo 1 of 1 : SP_2020_ST0005_289_18_20200227_00005.jpg

LM Start	1.48	Rating **	U	Issue No.	18
LM End	1.99	Issue Type +	Ma	Location *	WS
Category	Earthen Levee		GPS Latitude/Longitude		
			Start	End	
Item	Trim / Thin Trees		39.458053 °	39.461949 °	
			-121.636300 °	-121.629563 °	
DWR ID	DWR_ST0005_01_s_2017_18				
Comment Code					
T3 : Trim and thin trees to allow visibility of the ground and room to flood fight.					
Inspector Comment					
Trim/Thin Trees from Levee Mile 1.48 to 1.99. The LMA does not maintain the levee from Levee Mile 1.38 to 3.39.

View looking upstream of thick trees and vegetation blocking visibility on waterside.

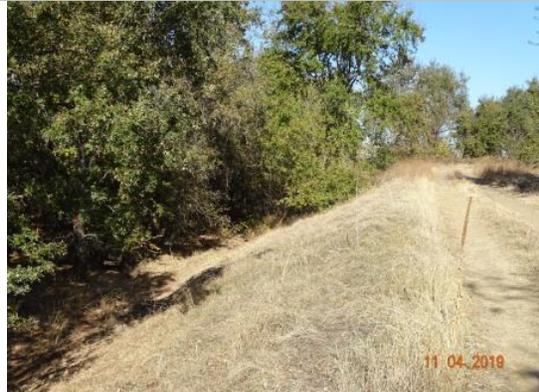
Photo 1 of 1 : SP_2020_ST0005_289_11_20200227_00003.jpg

LM Start	1.48	Rating **	U	Issue No.	11
LM End	3.25	Issue Type +	Ma	Location *	LS
Category	Earthen Levee		GPS Latitude/Longitude		
			Start	End	
Item	Trim / Thin Trees		39.458055 °	39.470312 °	
			-121.636300 °	-121.609242 °	
DWR ID	DWR_ST0005_01_s_2017_11				
Comment Code					
T3 : Trim and thin trees to allow visibility of the ground and room to flood fight.					
Inspector Comment					
Trim/Thin Trees from Levee Mile 1.48 to 3.25. The LMA does not maintain the levee from Levee Mile 1.38 to 3.39.

View looking upstream of thick trees blocking visibility on landside.

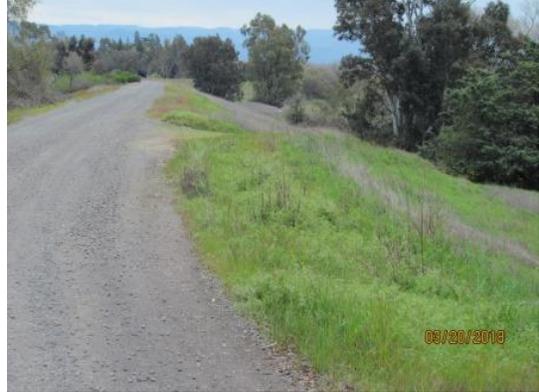
Photo 1 of 1 : SP_2020_ST0005_289_17_20200227_00004.jpg

LM Start	1.50	Rating **	U	Issue No.	17
LM End	1.96	Issue Type +	Ma	Location *	WS
Category	Earthen Levee		GPS Latitude/Longitude		
			Start	End	
Item	Vegetation		39.458131 °	39.461634 °	
			-121.635916 °	-121.629926 °	
DWR ID	DWR_ST0005_01_f_2017_17				
Comment Code					
V2 : Remove the wild growth other than native grasses from the levee slopes.					
Inspector Comment					
Maintain annual grasses from Levee Mile 1.50 to 1.96. The LMA does not maintain the levee from Levee Mile 1.38 to 3.39.

View looking upstream waterside of annual grasses that need to be maintained.

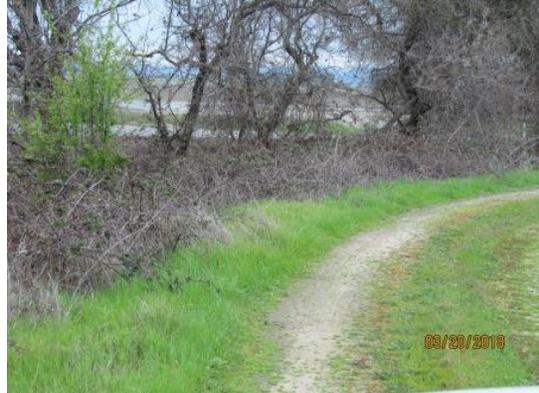
Photo 1 of 1 : SP_2020_ST0005_289_6_20200227_00002.jpg

LM Start	1.50	Rating **	U	Issue No.	6
LM End	2.63	Issue Type +	Ma	Location *	LS
Category	Earthen Levee		GPS Latitude/Longitude		
			Start	End	
Item	Vegetation		39.458132 °	39.466025 °	
			-121.635914 °	-121.618972 °	
DWR ID	DWR_ST0005_01_f_2016_6				
Comment Code					
V2 : Remove the wild growth other than native grasses from the levee slopes.					
Inspector Comment					
Blackberries covering slope from Levee Mile 1.50 to 2.63. The LMA does not maintain the levee from Levee Mile 1.38 to 3.39.

View looking upstream landside of blackberries that are covering the landside slope.

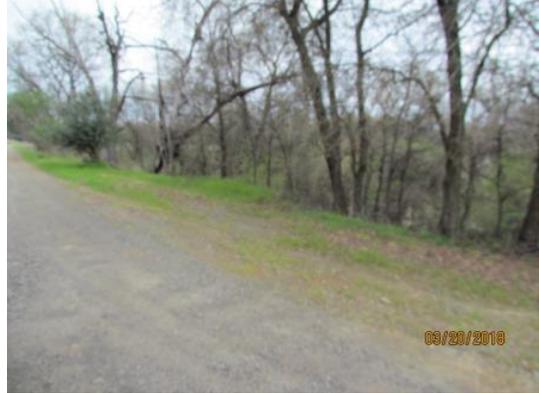
Photo 1 of 1 : SP_2020_ST0005_289_4_20200227_00001.jpg

LM Start	3.23	Rating **	U	Issue No.	4
LM End	3.27	Issue Type +	Ma	Location *	WS
Category	Earthen Levee		GPS Latitude/Longitude		
			Start	End	
Item	Trim / Thin Trees		39.470063 °	39.470558 °	
			-121.609264 °	-121.609215 °	
DWR ID	DWR_ST0005_01_s_2013_4				
Comment Code					
T3 : Trim and thin trees to allow visibility of the ground and room to flood fight.					
Inspector Comment					
Small trees 4" in diameter at chest height should be removed before they get too big from Levee Mile 3.23 to 3.27. Levee Mile 1.38 to 3.39 has never been maintained by the LMA.

View looking upstream waterside of small trees 4" in diameter at chest height should be removed before they get too big.
